Polyclad 767 is key in critical water pipeline rehab

Millions in Southern California rely on Etiwanda Pipeline

Location: Fontana and Rencho Cucamonga, California, USA

Owner: Metropolitan Water District of Southern California (MWD)

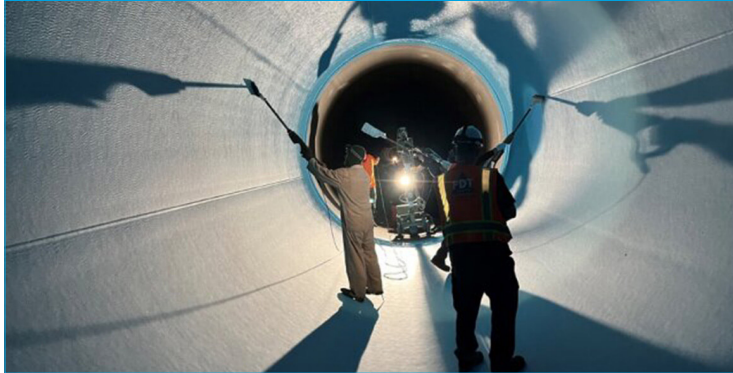
The cement mortar lining original to the 12-foot-wide pipeline was regarded an ordinary and sufficient corrosion protection method at the time. But more recently, intense droughts and inconsistent water supplies led to the mortar lining drying out and cracking apart in places. Newly exposed steel began to corrode. MWD took the pipeline out of service in 2022 to begin a rehabilitation.

Initially, authorities specified Polyclad 767 based on its strong performance against competing lining products in a trial. This self-priming rigid polyurethane meets AWWA C222 criteria and is UL-approved for ANSI/NSF 61 potable water contact.

Unwilling to let the ongoing pipeline rehabilitation stand between customers and water, MWD ordered an acceleration of the work. Crews were able to apply the lining faster because it cures quickly enough to pass back over it for a second coat shortly after the first while remaining accepting of that second coat without the need to clean or abrade. As a result, the pipeline returned to service two months ahead of schedule.
