Product Case History

Tangipahoa Water Tank - Elevated

OWNER: Tangipahoa Water District

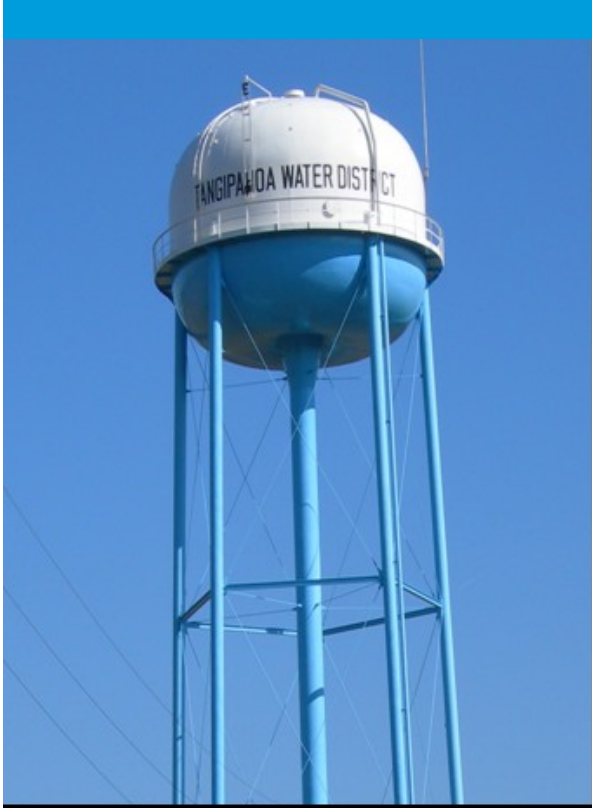
This elevated tank was deficient in its topcoat integrity. The owner wanted to upgrade its aesthetic value without removing the entire paint system.

Tangipahoa Water District chose Carboline's Rustbond sealer to penetrate the existing coating and rust, providing encapsulation of coating edge; thereby, reducing undercutting and peeling of existing system. This allowed the subsequent topcoat to be applied, extending the service life of the entire coating system.
