Chemical plant structural steel fireproofing

Switch to Pyrocrete 341 eliminates safety hazard

Owner: Major global chemical manufacturer

Location: Antwerp, Belgium

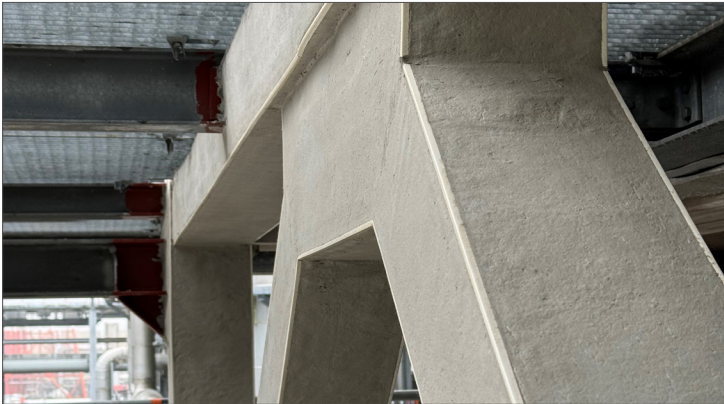
Structural steel columns and beams are shown following application of Pyrocrete 341. A prior passive fire protection product had degraded in this area of the owner's complex, with pieces of material falling from the steel and posing safety risks.

Following removal of the failed incumbent material and proper surface preparation of the steel, a primer coat of **Carboguard 893 SG** was applied. Then, new metal lath was installed. Finally, **Pyrocrete 341** was applied by trowel. This hybrid cementitious material represents the state of the art in industrial fire protection. It is rated to withstand hydrocarbon pool and jet fires as well as explosions and cryogenic exposures—all in a single applied layer. Finally, **Carboguard 1340** penetrating sealer was applied over the fireproofing. A sealer is appropriate in this corrosive environment; it also enhances the durability of the fireproofing.

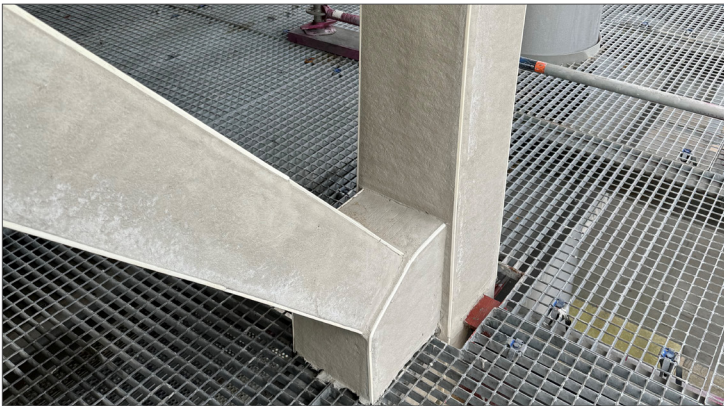
A certified applicator performed hand trowel installation of Pyrocrete 341. The work leading up to and including installation of heavy-duty cementitious fireproofing is highly technical. For best performance, it is recommended that only crews who are trained to handle the material are hired to install it.

Importantly, this system was installed by a certified specialty contractor deeply experienced in handling cementitious fireproofing materials including Pyrocrete 341. The contractor is well-regarded for the skill and experience of its staff—a critical benefit on any project involving safety-critical infrastructure.
