# Flexxide Elastomer saves schedule

## Making up for lost time in Tampa

**Location:** Tampa, Florida

**Products applied:**  
Flexxide High pH Primer  
Flexxide Elastomer

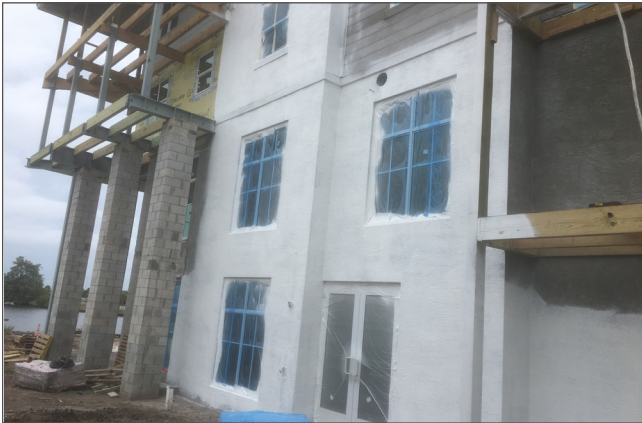
A section of one of the buildings of Town Westshore Luxury Apartments is shown during application of its exterior protective coating in May 2018.

But crews made up for lost time by applying Flexxide High pH Primer the morning after the stucco was installed, when its pH—recorded as high as 12 in some areas—was still too high to apply a normal coating.

But here, crews skipped the 28-day concrete-cure waiting game, moved directly onto finish coating, and brought the timeline back under control.

That finish was **Flexxide Elastomer**, low-VOC, low-odor acrylic-copolymer elastomeric material developed to withstand abusive coastal exposures, including intense sun and wind-driven rain. It also boasts excellent elongation to resist the forces of the normal movement of stucco or other masonry surfaces.

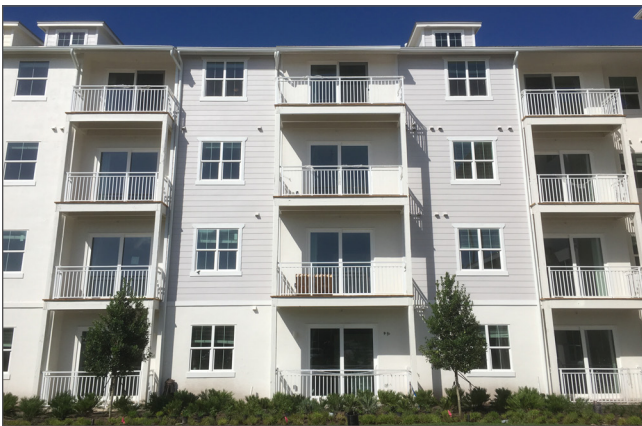
One of the buildings of Town Westshore Luxury Apartments is shown during a site visit in June 2024, six years after the exterior coating was applied.
