Fast-cure epoxy reduces treatment plant downtime

Hydroplate® 6500 speeds emergency lining repair

Location: Lake City, Florida

Lining system: Hydroplate 6500

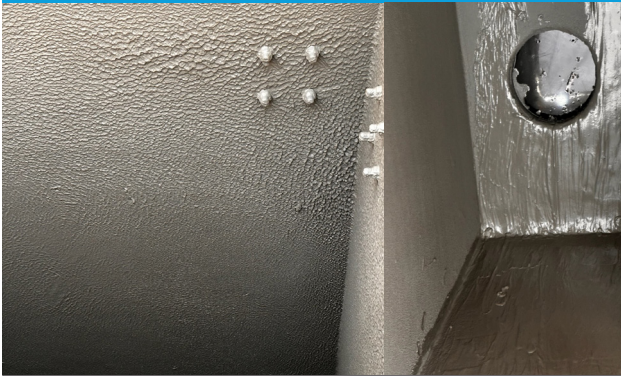
At this wastewater treatment plant, the splitter box's prior coal tar epoxy lining system failed, resulting in widespread pitting of the underlying steel. An emergency repair was initiated, consisting of the removal of the existing coal tar epoxy followed by direct-to-metal spray application of **Hydroplate 6500**.
