Product Case History

CCU Water Treatment Plant

PRODUCTS: Carboguard 690, Carboguard 510 SG, Plasite 4550 S

PROJECT DESCRIPTION:

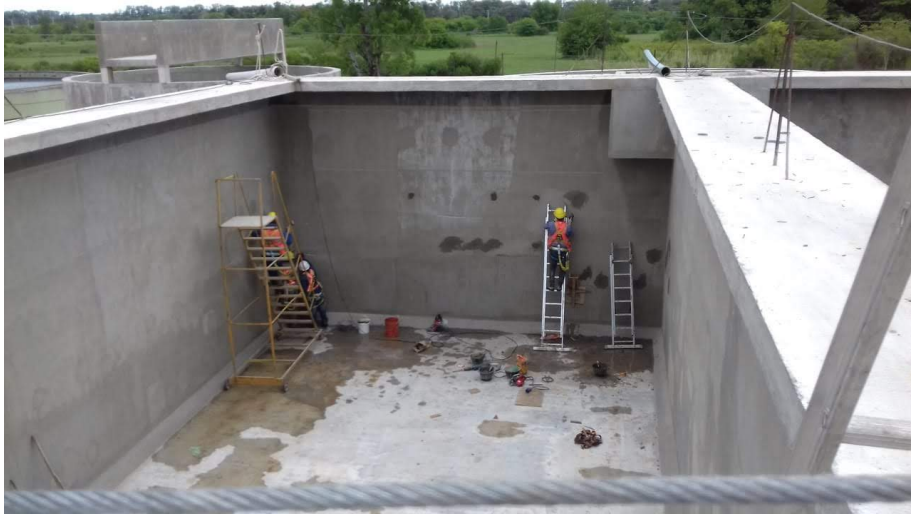
Plasite 4550S was applied to a concrete collection pool to provide protection against strong acid or caustic chemicals.

Plasite 4550 S was chosen as it is a 100% solid high performance epoxy lining system. This lining system needed to be chemically resistant and applied in one single coat.

Carboguard 510 SG was selected to repair and resurface the concrete prior to the application of Plasite 4550S. 510 SG was selected due to great application properties and quick topcoat times.
